Analysis of the Accidental Explosion at Pepcon, Henderson, Nevada, May 4, 1988

Jack W. Reed

ANALYSIS OF THE ACCIDENTAL EXPLOSION AT PEPCON,
HENDERSON, NEVADA, MAY 4, 1988

ABSTRACT

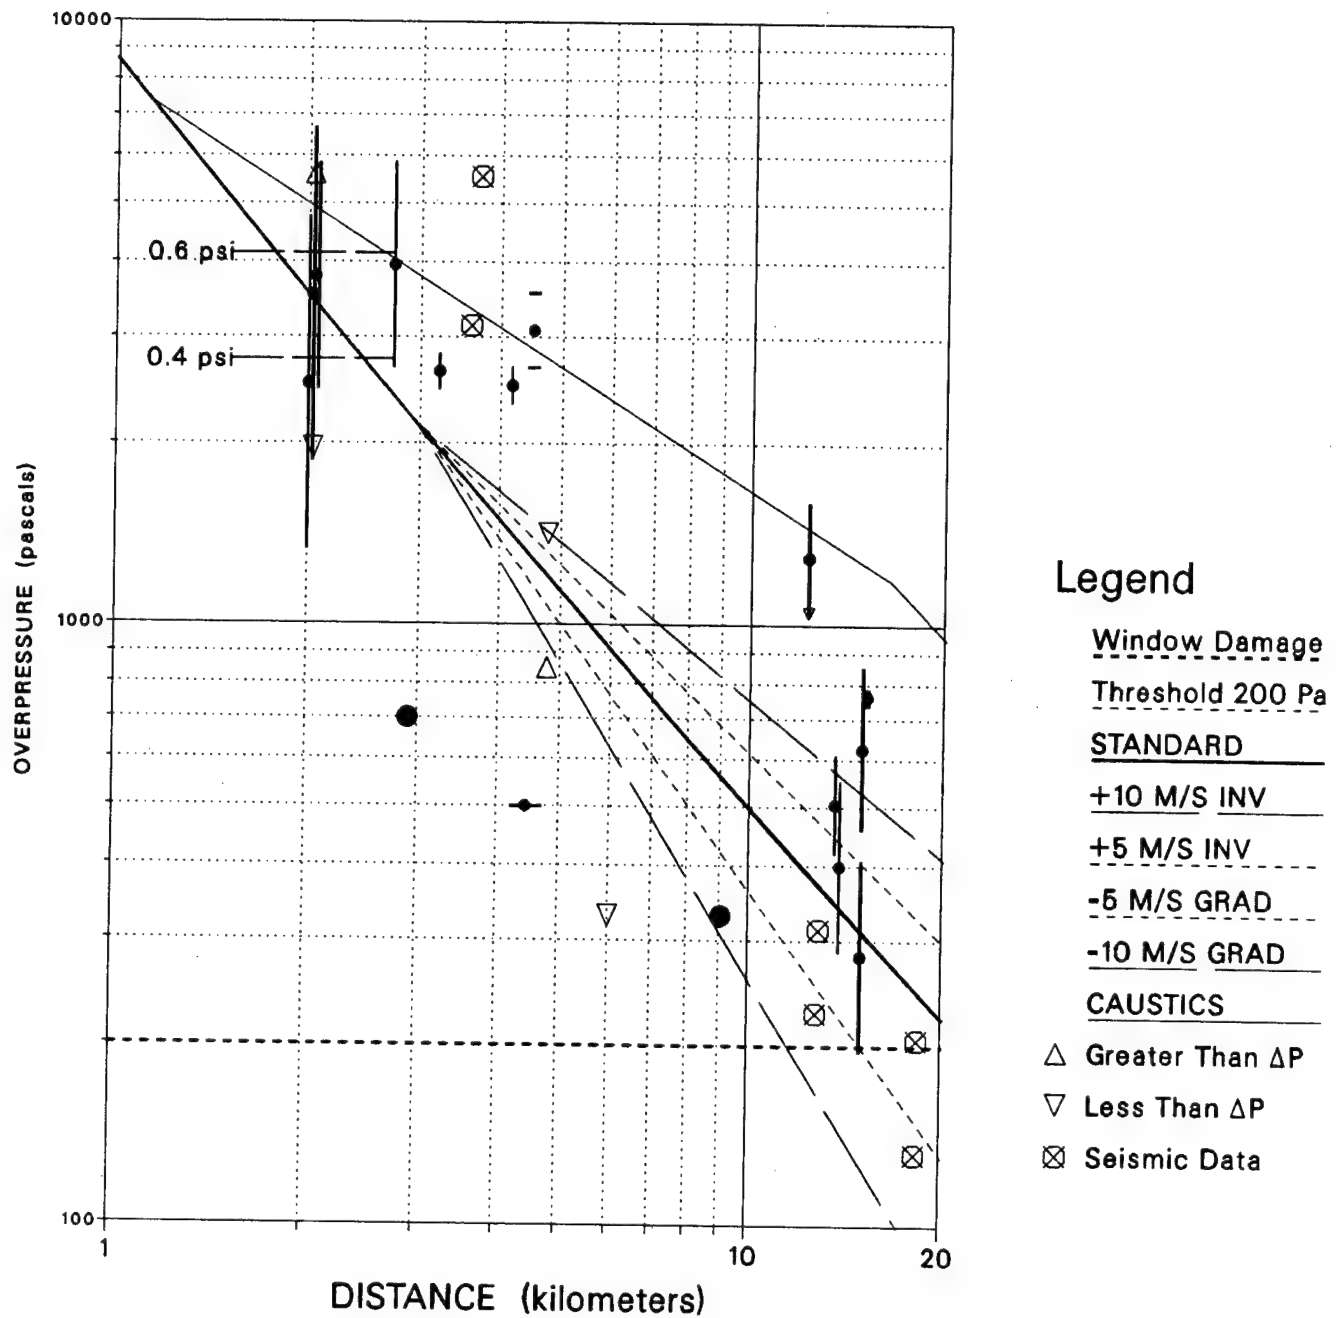
Figure 10. Airblast overpressure versus distance curves for 250-ton TNT surface burst at PEPCON, with data estimated from damage evaluations. (Vertical bars indicate range of overpressures needed to give observed damage probabilities).

Notes from a two-day survey of damages in Henderson and Las Vegas have been included in Appendix A. Since TTU surveyors reported considerable detail on their tape recorders, only relatively few, seemingly striking or important features were written down by this author. These have been interpreted, through use of Figures 5 through 8, as estimated overpressure-distance values shown in Figure 10. Interpretive details are listed in Tables 9 and 10.

East of PEPCON, Henderson residences extend to Albany Way, at 2.9 km where only about one broken window per house appeared to result from around 700-Pa overpressure, shown by a large solid circle in Figure 10. Visibility was limited in this older community, however, with high walls and trees obscuring likely additional damaged panes. Near Crest and Buchanan Streets, at 3.21 km, conversation with a resident disclosed 6 broken of 16 exposed SS panes; all were double-pane insulating windows. This inferred around 2600-Pa overpressure, in closer agreement with the Standard curve.

In summary of these spot damage interpretations in Figure 10, the cloud of data does generally surround a 1-kt NE Standard curve, reinforcing the initial estimate that the largest PEPCON explosion was about equivalent to 250 tons, possibly 500 tons, of chemical high explosives. But ammonium perchlorate is "not detonable", so there are no federal, state, or OSHA standards for treating and handling it as such, nor TNT equivalences for estimating how much AP actually exploded.

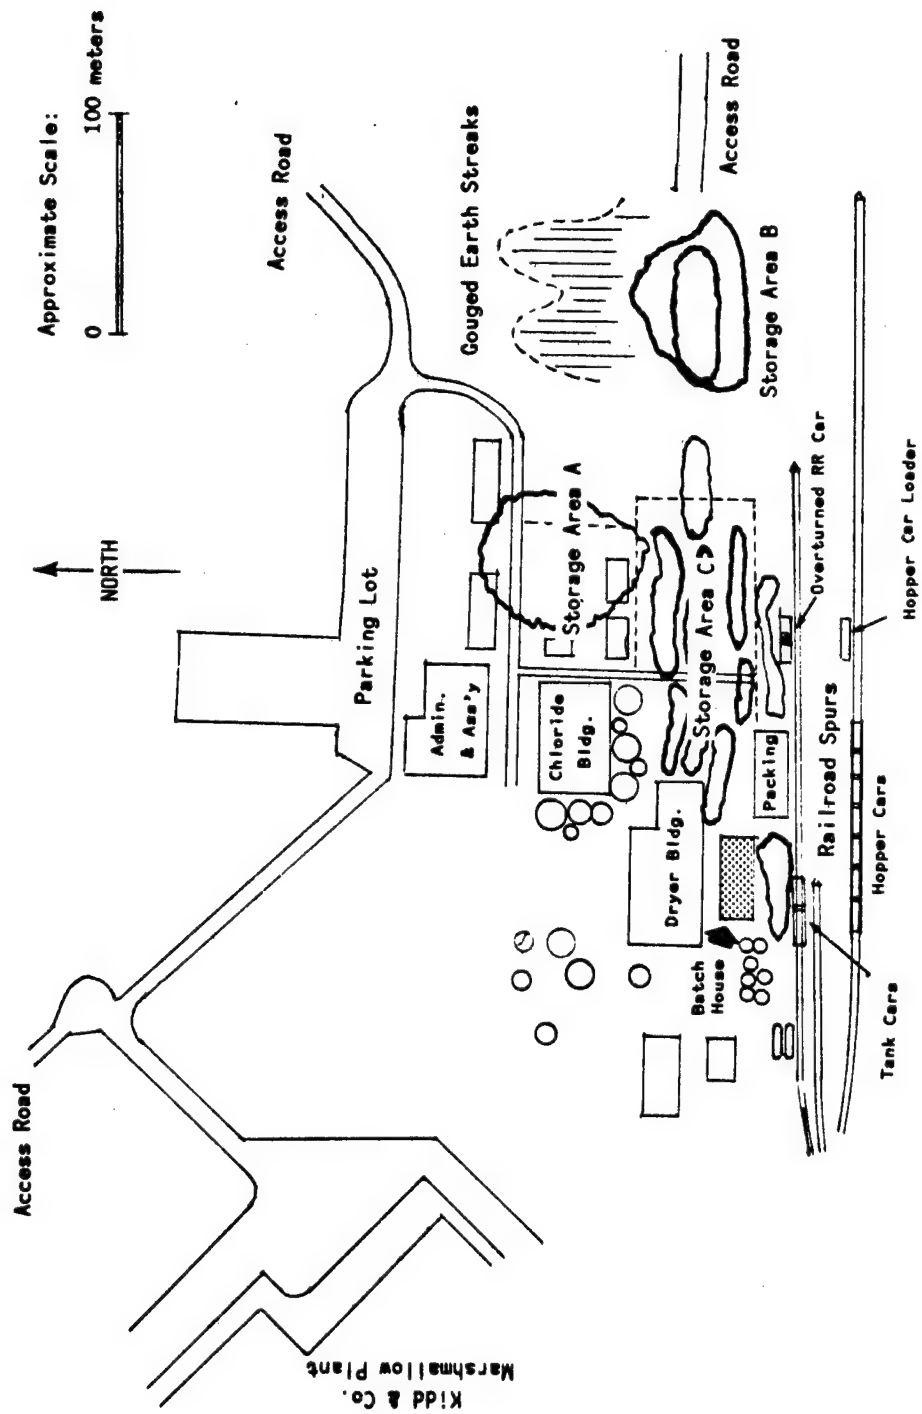
Figure 12. Sketch map of Pacific Engineering Company (PEPCON), Henderson, Nevada, with primary explosion damage features.

Aerial photography was flown over the PEPCON region by EG&G, instrumentation contractors to DOE-NVO, on May 10, 1988. The expectation was that an explosion crater could be dimensioned as an additional yield estimator. Since there was no clear crater formation comparable to ones observed after point explosion tests, no yield scaling was possible. Their photographs did assist in estimating what happened, however, as well as help clear up some map scaling problems that were encountered in connecting the Henderson map in Figure 9 to the Las Vegas map in Figure 11. A sketch of the PEPCON facility in Figure 12, annotated with help from newspaper stories in Appendix B, shows where the initial fire broke out of control in the Batch House, then spread to the Dryer Building and on to the Chloride Building. It is not clear where the first large explosion occurred. What is obvious from these aerial photographs is that the latest and largest explosion occurred in Storage Yard B, nearly 300 m east of the Batch House.

Although it is not important to analysis of damage, overwhelmingly caused by the largest explosion, it might appear that the first explosion occurred at the Batch House and a small adjacent storage area. The east end of the Batch House appears to have been blown away. The second, dark explosion could have been a relatively low-order detonation of the 607-Mg AP in Storage Area A.
